DYERS RUN NO. 3 DAM

(NDI NO. PA-00676

PHASE I INSPECTION REPORT,

①1 **FEBRUARY 1981**

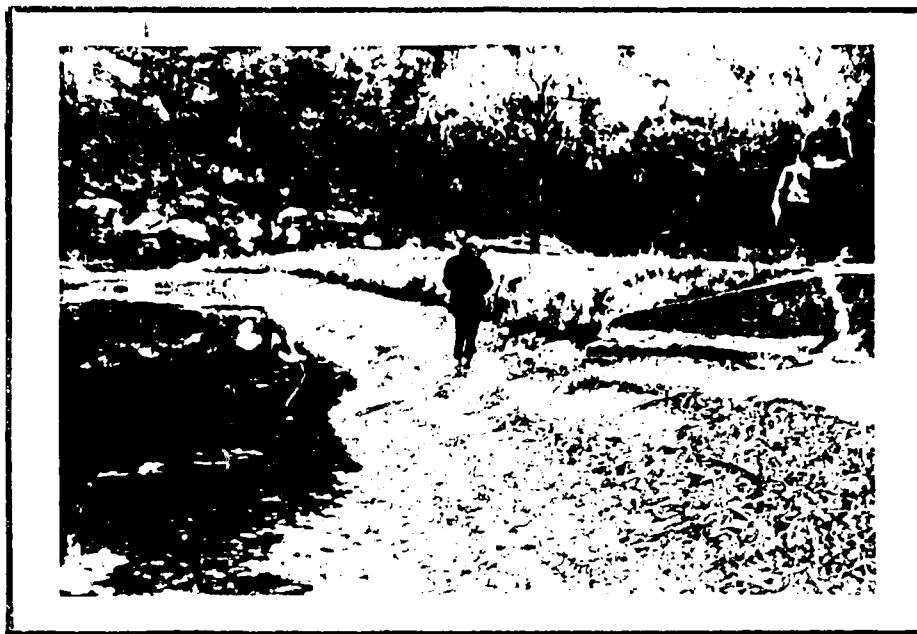
The broad crested spillway weir is located in the right abutment and is constructed of large stone slabs (Photograph No. 6). On the right side, the abutment is formed by natural rock. On the left side there is a small concrete wingwall in the forebay which has cracked (Photograph No. 4). This condition gives a poor appearance, but does

The spillway weir and discharge channel are in good condition. There were no signs of instability except that the left forebay wall had settled and cracked. The impervious blanket is upstream from the spillway and there were no signs of seepage from this area. Most of the spillway chute has a rock lined bottom.

UPSTREAM SLOPE AND LEFT SPILLWAY ABUTMENT WALL - NO. 4

The left wingwall should be repaired for proper functioning during periods of large discharges. The pipes do not have an upstream closure. This, however, is not considered serious for this type of structure.

1. That measures shall be taken to provide an adequate spillway capacity.
2. That the left forebay wall be repaired or replaced.
3. That the valves on the blow-off pipes be maintained and operated on a regular basis.

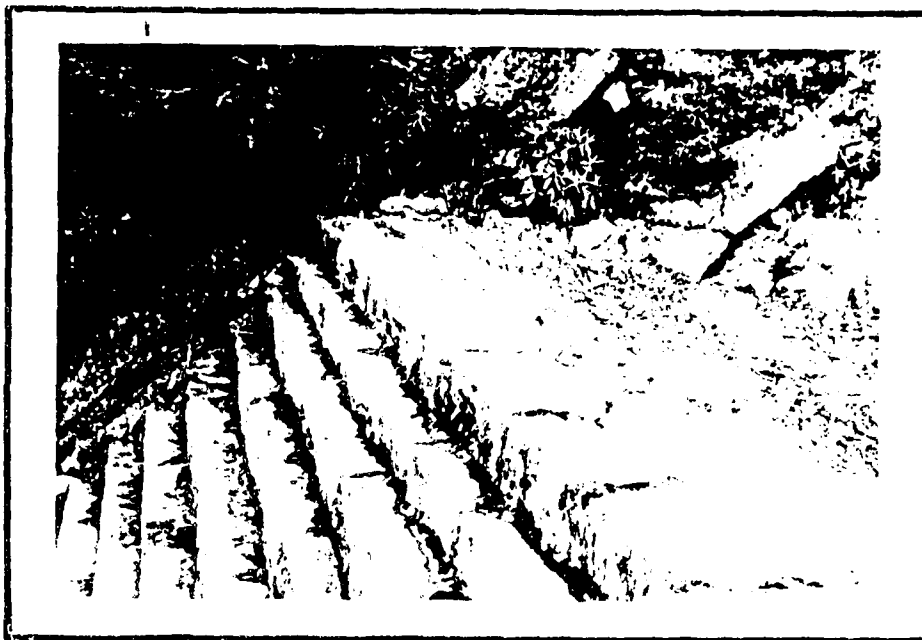
DOWNSTREAM STEPS OF SPILLWAY -- NC. 6
